Document Date: 02/15/2023

AOC TSD Attachment list for groundwater remediation, VSQG.

## STATE OF NORTH CAROLINA DEPARTMENT OF ENVIRONMENTAL QUALITY DIVISION OF WASTE MANAGEMENT HAZARDOUS WASTE SECTION COMPLIANCE EVALUATION INSPECTION (CEI) REPORT

Name: Seaboard Chemical Corporation

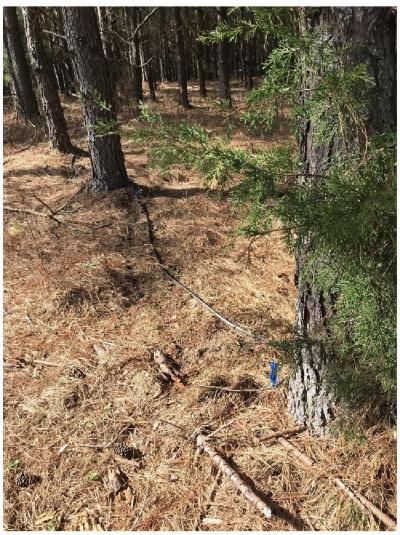
Mr. Glover and Mr. Craig Coslett led the group to the West Phytoremediation Zone. The phytoremediation system was visually observed, with the rows of trees that appeared green and healthy. Treated water distribution line flow meters were checked, which indicated the water lines operating. Newer drip lines were observed on the surface at the base of the trees. Mr. Glover explained this was to better facilitate monitoring and repair of the irrigation lines, and that freezing was not a major concern based on the constant flow of water, and flexible lines here, but heat trace tape was used on valves and other components prior to the The increased quarterly surface water monitoring from the approved system improvements will help the Seaboard II group evaluate conditions after the irrigation line replacements. Two observation wells in the area were checked, OW-SIS-3, which was no longer in use but appeared to be intact, and OW-SF-1, which was also intact and maintained. The facility maintains lysimeters in order to compare water volume and concentration with mass removal. The facility tracks and documents phytoremediation system maintenance and performance.

Photo: 1 of 2, February 15, 2023, Western Phytoremediation Zone, (Zones 1-11), with the replacement irrigation line visible.

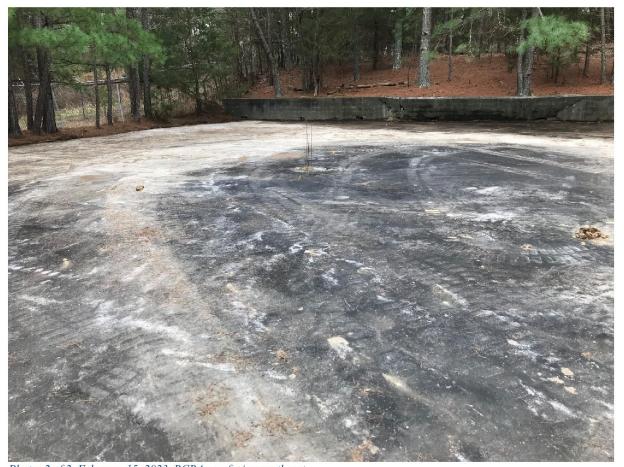
The former Seaboard Chemical Corporation property was secured with fencing, gate, and lock. The RCRA cap over was found in good, well-maintained condition.

Photo: 2 of 2, February 15, 2023, RCRA cap facing southeast.
