Facility Name/Subject: Former Seaboard Chemical Corporation

**STATE OF NORTH CAROLINA
DEPARTMENT OF ENVIRONMENTAL QUALITY
DIVISION OF WASTE MANAGEMENT
HAZARDOUS WASTE SECTION
COMPLIANCE EVALUATION INSPECTION (CEI) REPORT**

6. **DATE OF INSPECTION:** December 5, 2023, START: 10:00 AM END: 1:00 PM
7. **PURPOSE OF EVALUATION:** An annual inspection to determine compliance with the hazardous waste management requirements set forth in North Carolina Solid Waste Management Act, N.C.G.S. Chapter 130A, Article 9, and the North Carolina Hazardous Waste Management Rules, 15A NCAC Subchapter 13A.

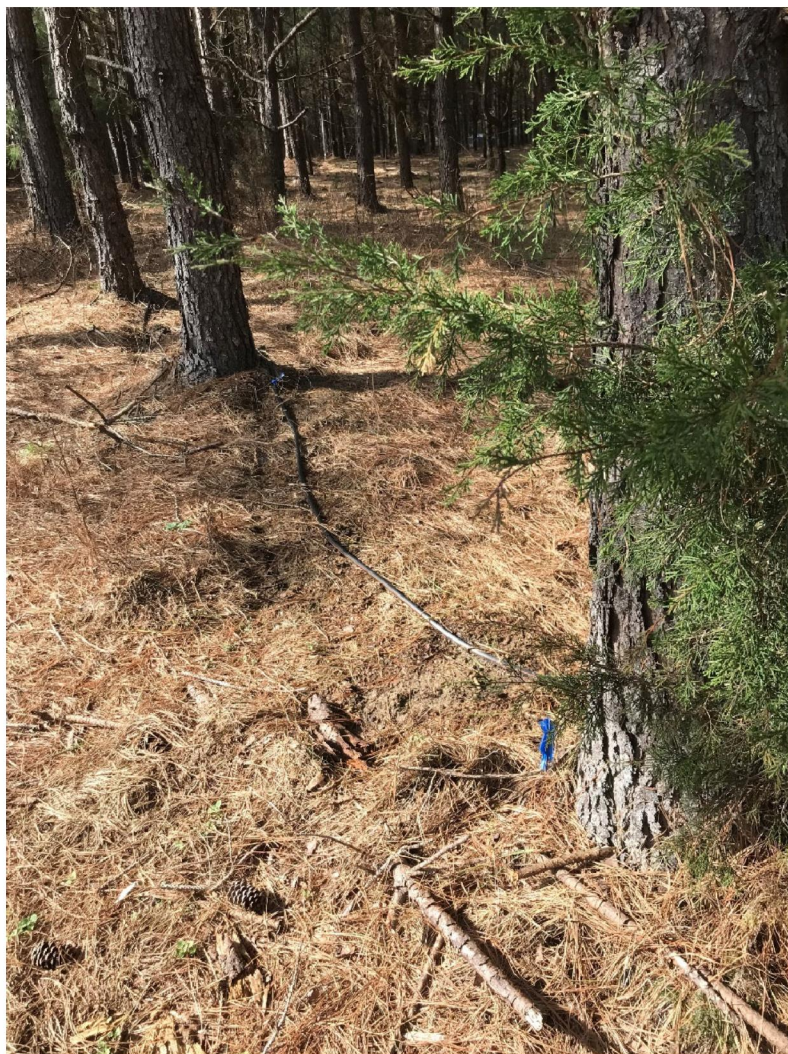
The group walked to the West Phytoremediation Zone to review the completion of the irrigation system redesign. A total of twenty-four miles of HDPE flexible pipe for irrigation drip lines were replaced to ensure biofouling and scale were not blocking or restricting flow. The drip lines are closer to the surface but covered for protection against mowing and run along the base of trees in rows, secured every five feet with soil staples. Freezing was not a major concern based on the flow of water in frequent cycles, and the strength and flexibility of the HDPE materials used, but heat trace tape is used on valves and other components prior to the irrigation drip lines. Part of the redesign included higher flow to higher ground and drier areas, and lower flow lines to lower, wetter areas. The facility still maintains lysimeters in order to compare water volume and concentration with mass removal. The facility also tracks and documents phytoremediation system maintenance and performance. The phytoremediation system has included loblolly pines, with red cedars recently added depending on soil conditions. In general, the irrigation and establishment of the tree stands has improved soil conditions for the trees. The phytoremediation system was visually observed, with the rows of trees that appeared green and healthy, with a full canopy and pine straw litter limiting undergrowth for most of the West Phytoremediation Zone.

Photo: 1 of 3, from February 15, 2023, Western Phytoremediation Zone, (Zones 1-11). This area was observed to be similarly operating and in good condition on December 5, 2023.

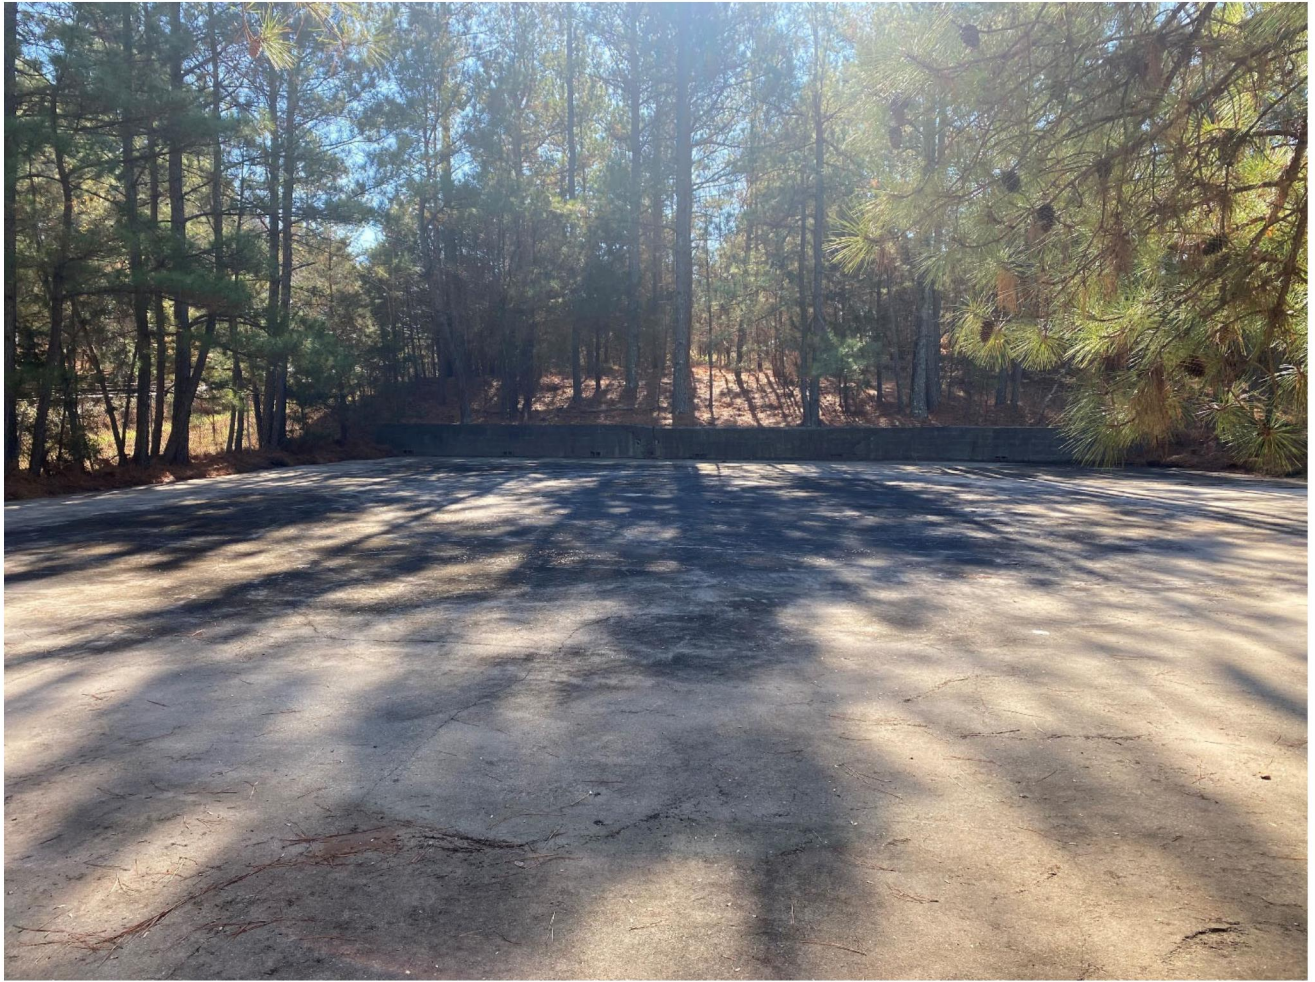
The inspection continued at the closed Seaboard Chemical Corporation property, which was accessed through the south facing gate on Riverdale Drive. The gate and fencing were in good condition and secured. The group walked the former foundation areas, which are concrete slabs that are overall intact, with no evidence of erosion or site disturbance. The RCRA cap is over the former SCC Pond 3 management unit and was found clean, dry, and free of pine needles, sediment, or debris, to facilitate the inspection of the entire cap surface. An epoxy patch material was used to repair a small area of surface spalling and cracks on the concrete slab. The integrity of the RCRA cap was intact and being well maintained in good condition.

Photo 2 of 3, December 5, 2023, the RCRA Cap facing south.

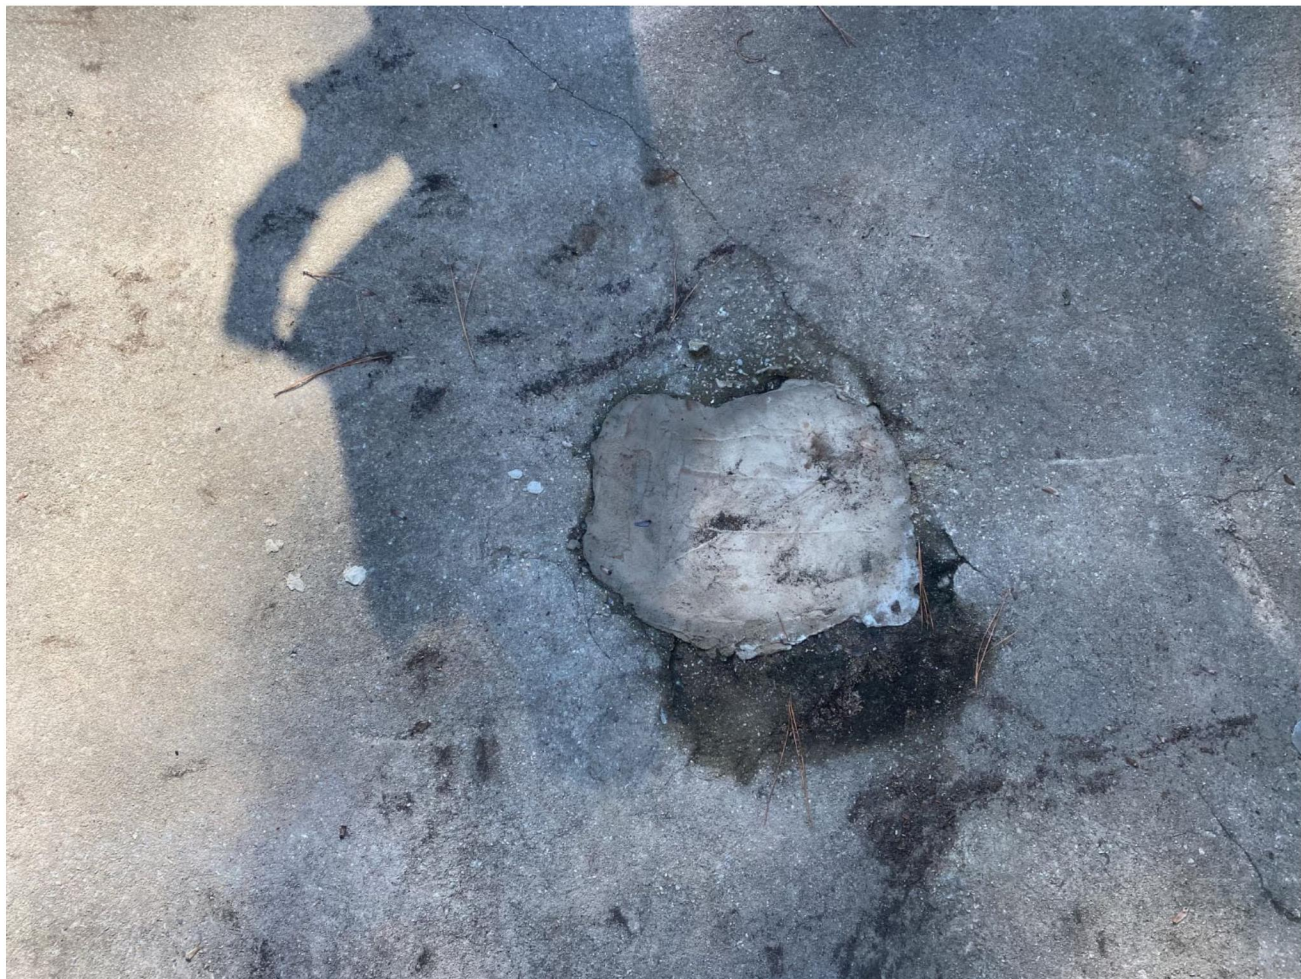
Photo 3 of 3, December 5, 2023, RCRA Cap surface spalling spot cleaned out and repaired, located near the north edge.
